Outer Harbor Channel Widening Project - Monthly Report for July 2019

Monthly Environmental Report – July 2019

PROJECT NAME: Port Adelaide Outer Harbor Channel Widening
PROJECT NUMBER: 036-101315

Adelaide Outer Harbor Channel Widening Project: July Water Quality Monitoring and Validation Report

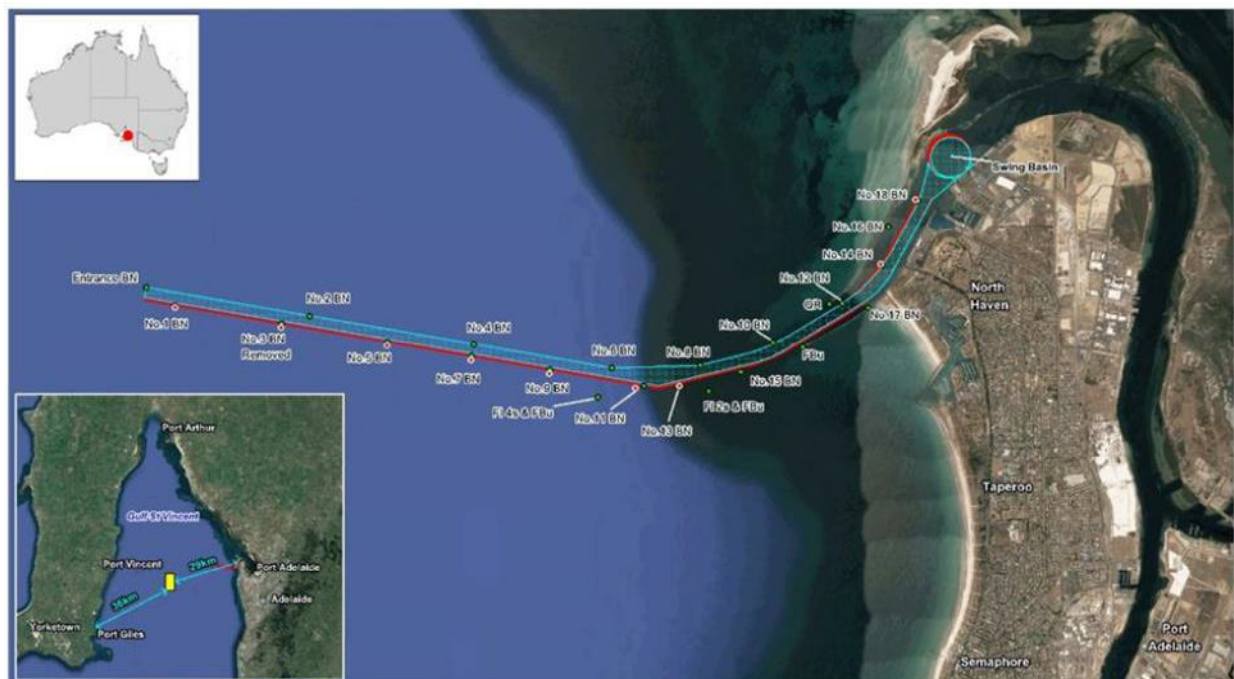
Figure 2.1: Overview Project area with outer shipping channel and turning basin

To meet this growth, the existing channel will be widened by 40m to a total width of 170m. The swing basin will be widened from 505m to 560m. The widening footprint of the channel and turning basin are illustrated by the red line in Figure 2.1.

The dredged material will be transported to a designated Dredge Material Placement Area (DMPA), located approximately 30km offshore in the Gulf of St Vincent (yellow box in Figure 2.1). This area is approximately 7km by 5km in size and located in deep water (>30m), thereby avoiding major shipping routes.

The Port of Adelaide is the primary port in South Australia, located at Outer Harbor (approximately 14km north-west of the Adelaide CBD) in South Australia (Figure 2.1). The port is operated by Flinders Ports and handles a diverse array of inbound and outbound cargoes, contributing significantly to the State's economic activity. A significant amount of this trade is containerized, and Outer Harbor is the location of the Flinders Adelaide Container Terminal and the Port Adelaide Passenger Terminal which contribute significantly to South Australia's import and export of goods and visitors.

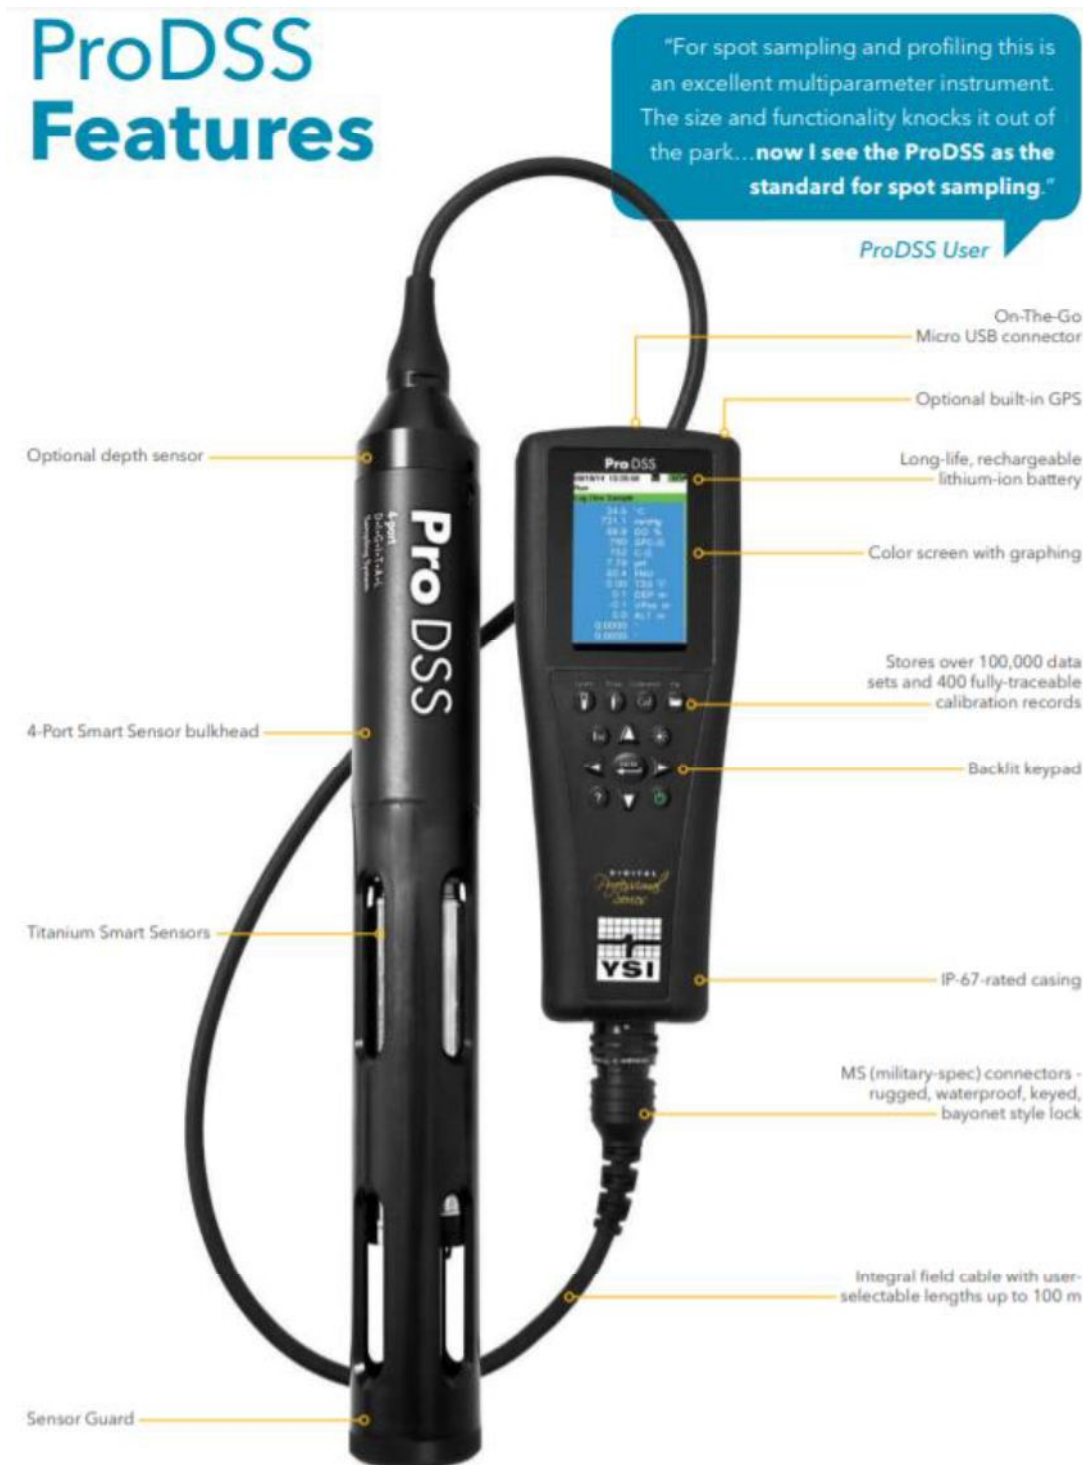
ProDSS Sensor Specifications

Sensor/Parameter	Range	Resolution	Accuracy
Temperature	-5 to 70 °C (temperature compensation range for DO mg/L measurement: -5 to 50 °C)	0.1 °C or 0.1 °F (user selectable)	±0.2 °C
pH	0 to 14 pH units	0.01 pH units	±0.2 pH units
ORP	-1999 to 1999 mV	0.1 mV	±20 mV
Dissolved Oxygen	0 to 500%, 0 to 50 mg/L	0.01 mg/L and 0.1%, or 0.1 mg/L and 1% (user selectable)	0 to 200%: ±1% of reading or 1% saturation, whichever is greater 200 to 500%: ±8% of reading 0 to 20 mg/L: ±0.1 mg/L or 1% of reading, whichever is greater 20 to 50 mg/L: ±8% of reading
Barometer	375 to 825 mmHg	0.1 mmHg	±1.5 mmHg from 0 to 50 °C
Conductivity	0 to 200 mS/cm	0.001, 0.01 or 0.1 µS/cm (range dependent)	0 - 100 mS/cm: ±0.5% of reading or .001 mS/cm, whichever is greater 100 - 200 mS/cm: ±1.0% of reading
Specific Conductance*	0 to 200 mS/cm	0.001, 0.01, 0.1 mS/cm	0 - 100 mS/cm: ±0.5% of reading or .001 mS/cm, whichever is greater 100 - 200 mS/cm: ±1.0% of reading. User selectable reference temperature (15 to 25 °C; default 25 °C) and compensation coefficient (0 to 4%/°C; default 1.91%)

Furthermore, on the 18th of July and on the 20th of July readings were verified with a hand-held turbidity sensor, similar to the sensor installed on the monitoring stations. The handheld sensor was lowered to a depth of approximately 1m below the water surface, at similar level as the buoy sensors, for a period of approximately 1 minute. The results of this verification can be found in Table 3. Hand-held turbidity readings were slightly higher compared to the turbidity buoy readings. The differences on the 21st of July were still within the margin of the accuracy of the sensors. The differences on the 19th of July were probably not within the margin of the accuracy of the sensors.

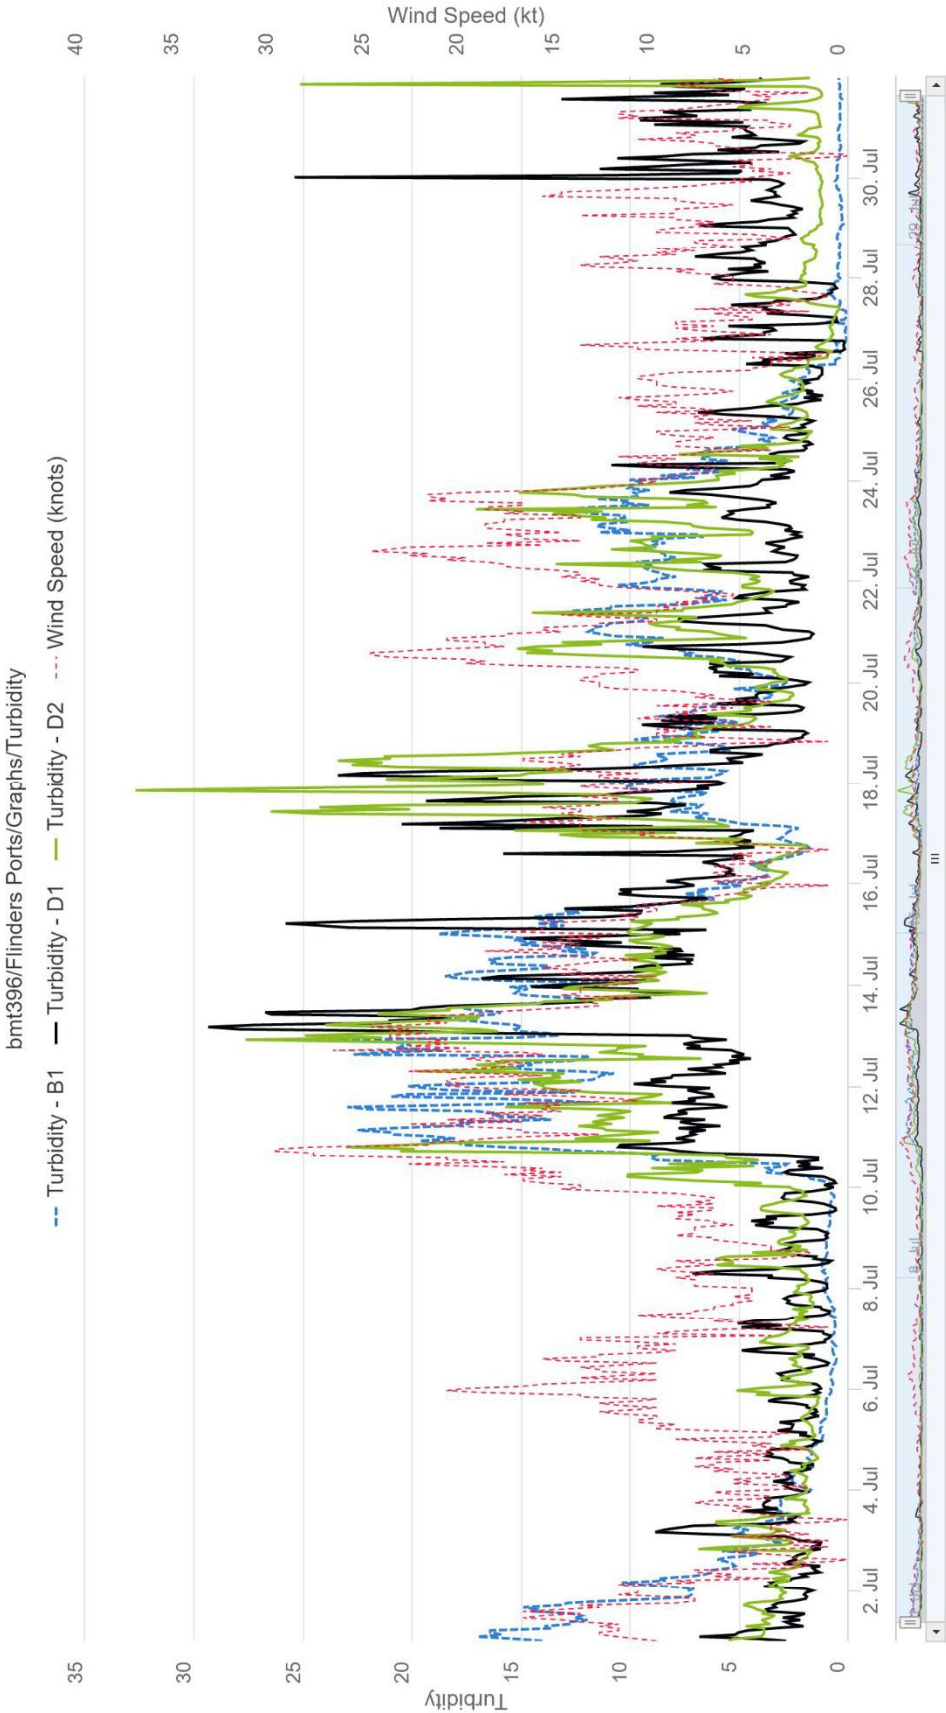
Figure 4-1 Raw turbidity data (NTU) for B1, D1 & D2 (1st July 31st July)

Adverse weather conditions were experienced in the month of July, with winds regularly above 20km/hr experienced (Refer to Table 4-1). There was a general correlation between rising turbidity and wind events at all monitoring locations, particularly when wind was from a westerly direction.

These adverse conditions resulted in HOLD exceedances of the 15-day rolling median turbidity on the 19th July and 21st July at D2/B1 and D1 respectively. In the lead-up to the exceedance, Flinders Ports and the contractor undertook a series of measures to reduce sediment plumes generated from the TSHD (refer to the Boskalis July monthly report for further detail) including:
