Outer Harbor Channel Widening Project - Monthly Report for June 2019

Monthly Environmental Report – June 2019

PROJECT NAME: Port Adelaide Outer Harbor Channel Widening
PROJECT NUMBER: 036-101315

Adelaide Outer Harbor Channel Widening Project: June Water Quality Monitoring and Validation Report

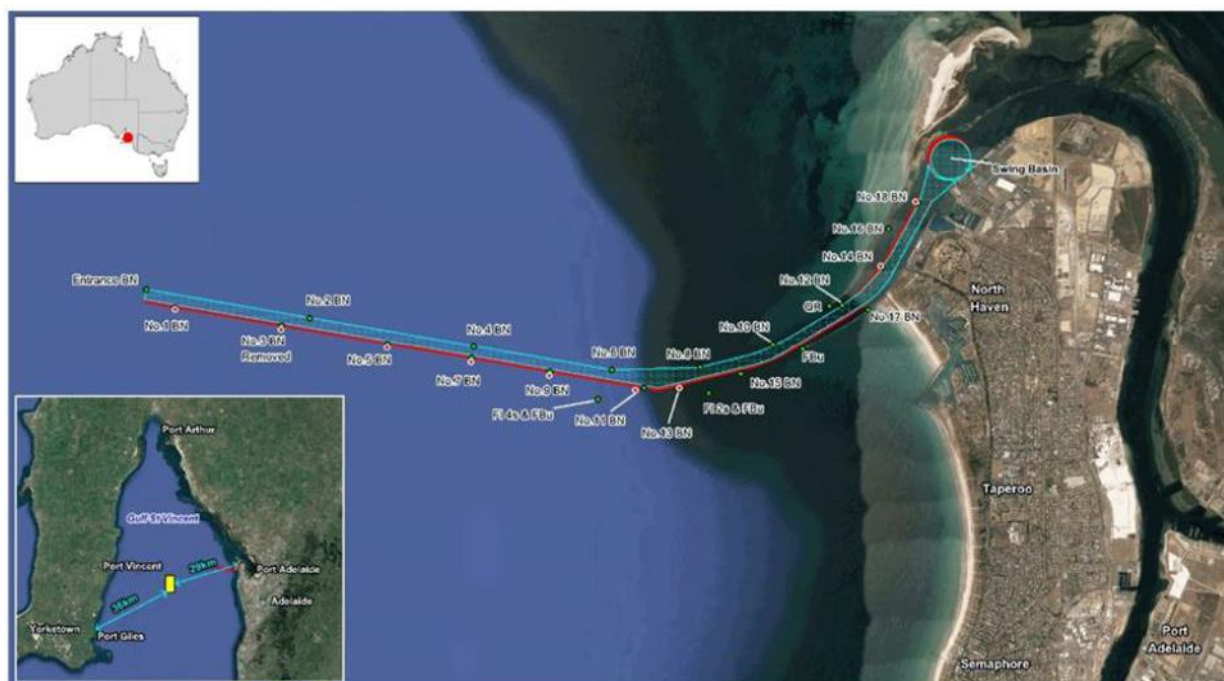
Figure 2.1: Overview Project area with outer shipping channel and turning basin

To meet this growth, the existing channel will be widened by 40m to a total width of 170m. The swing basin will be widened from 505m to 560m. The widening footprint of the channel and turning basin are illustrated by the red line in Figure 2.1.

The dredged material will be transported to a designated Dredge Material Placement Area (DMPA), located approximately 30km offshore in the Gulf of St Vincent (yellow box in Figure 2.1). This area is approximately 7km by 5km in size and located in deep water (>30m), thereby avoiding major shipping routes.

The Port of Adelaide is the primary port in South Australia, located at Outer Harbor (approximately 14km north-west of the Adelaide CBD) in South Australia (Figure 2.1). The port is operated by Flinders Ports and handles a diverse array of inbound and outbound cargoes, contributing significantly to the State's economic activity. A significant amount of this trade is containerized, and Outer Harbor is the location of the Flinders Adelaide Container Terminal and the Port Adelaide Passenger Terminal which contribute significantly to South Australia's import and export of goods and visitors.

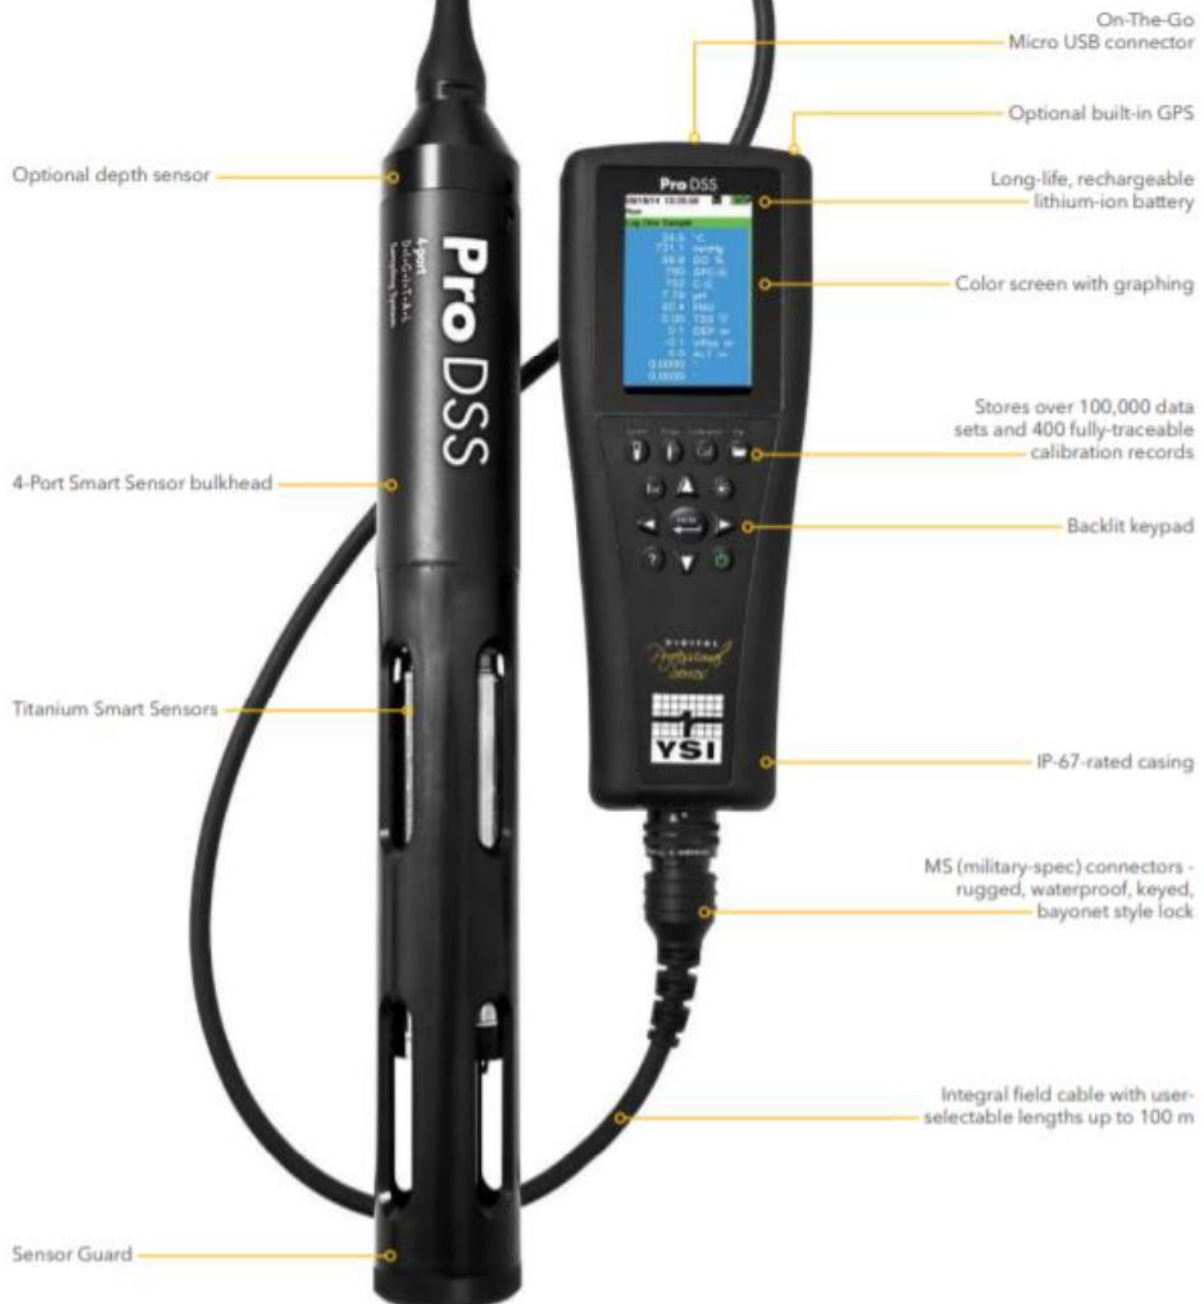
ProDSS Sensor Specifications

Sensor/Parameter	Range	Resolution	Accuracy
Temperature	-5 to 70 °C (temperature compensation range for DO mg/L measurement: -5 to 50 °C)	0.1 °C or 0.1 °F (user selectable)	±0.2 °C
pH	0 to 14 pH units	0.01 pH units	±0.2 pH units
ORP	-1999 to 1999 mV	0.1 mV	±20 mV
Dissolved Oxygen	0 to 500%, 0 to 50 mg/L	0.01 mg/L and 0.1%, or 0.1 mg/L and 1% (user selectable)	0 to 200%: ±1% of reading or 1% saturation, whichever is greater 200 to 500%: ±8% of reading 0 to 20 mg/L: ±0.1 mg/L or 1% of reading, whichever is greater 20 to 50 mg/L: ±8% of reading
Barometer	375 to 825 mmHg	0.1 mmHg	±1.5 mmHg from 0 to 50 °C
Conductivity	0 to 200 mS/cm	0.001, 0.01 or 0.1 µS/cm (range dependent)	0 - 100 mS/cm: ±0.5% of reading or .001 mS/cm, whichever is greater 100 - 200 mS/cm: ±1.0% of reading
Specific Conductance*	0 to 200 mS/cm	0.001, 0.01, 0.1 mS/cm	0 - 100 mS/cm: ±0.5% of reading or .001 mS/cm, whichever is greater 100 - 200 mS/cm: ±1.0% of reading. User selectable reference temperature (15 to 25 °C; default 25 °C) and compensation coefficient (0 to 4%/°C; default 1.91%)

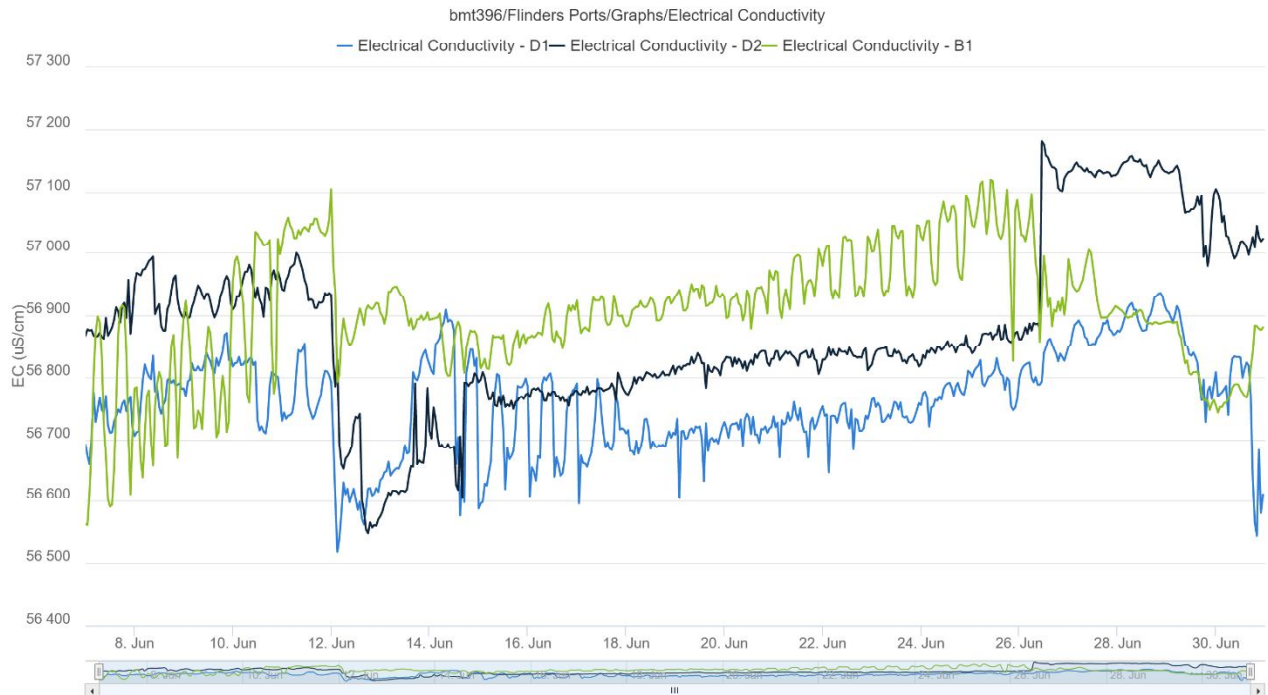
Figure 4-6 Electrical Conductivity (µS/cm) for B1, D1 and D2 – June 2019

Electrical Conductivity (EC) ranged between 56,000 and 57,500 μ S/cm, as shown in Figure 4-6.
