Outer Harbor Channel Widening Project - Monthly Report for September 2019

Monthly Environmental Report – September 2019

PROJECT NAME: Port Adelaide Outer Harbor Channel Widening
PROJECT NUMBER: 036-10315

Adelaide Outer Harbor Channel Widening Project: September Water Quality Monitoring and Validation Report

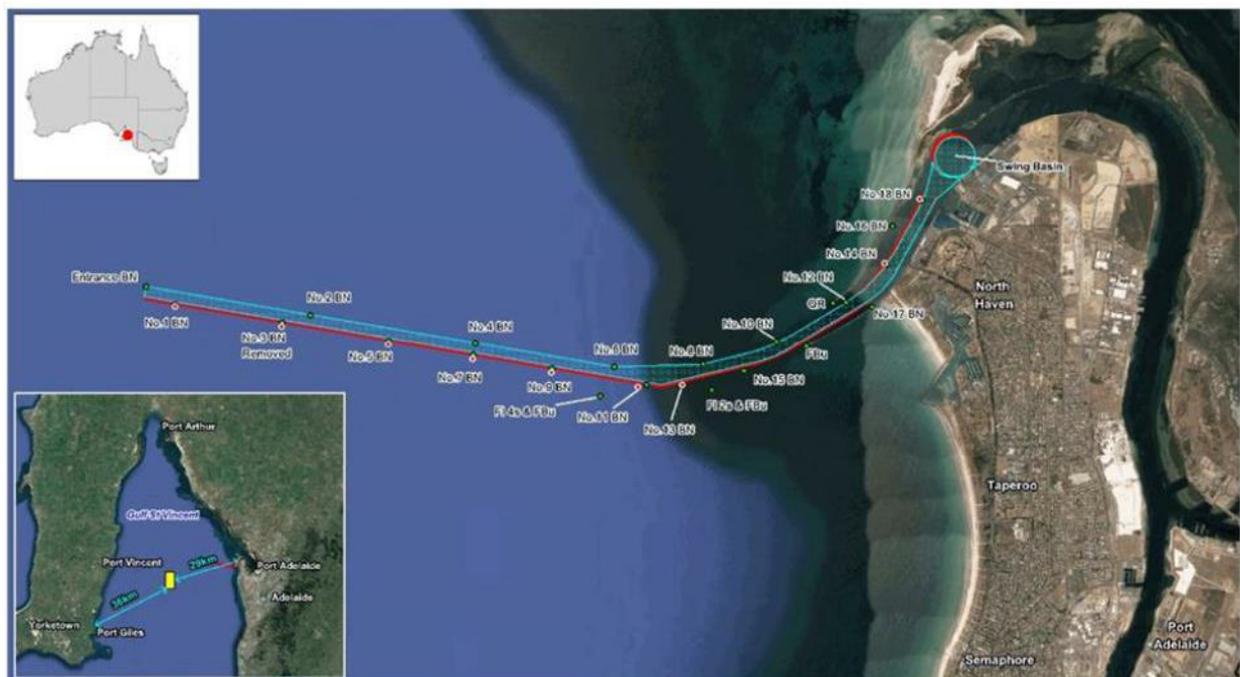
Figure 2.1: Overview Project area with outer shipping channel and turning basin

To meet this growth, the existing channel will be widened by 40m to a total width of 170m. The swing basin will be widened from 505m to 560m. The widening footprint of the channel and turning basin are illustrated by the red line in Figure 2.1.

The dredged material will be transported to a designated Dredge Material Placement Area (DMPA), located approximately 30km offshore in the Gulf of St Vincent (yellow box in Figure 2.1). This area is approximately 7km by 5km in size and located in deep water (>30m), thereby avoiding major shipping routes.

The Port of Adelaide is the primary port in South Australia, located at Outer Harbor (approximately 14km north-west of the Adelaide CBD) in South Australia (Figure 2.1). The port is operated by Flinders Ports and handles a diverse array of inbound and outbound cargoes, contributing significantly to the State's economic activity. A significant amount of this trade is containerized, and Outer Harbor is the location of the Flinders Adelaide Container Terminal and the Port Adelaide Passenger Terminal which contribute significantly to South Australia's import and export of goods and visitors.

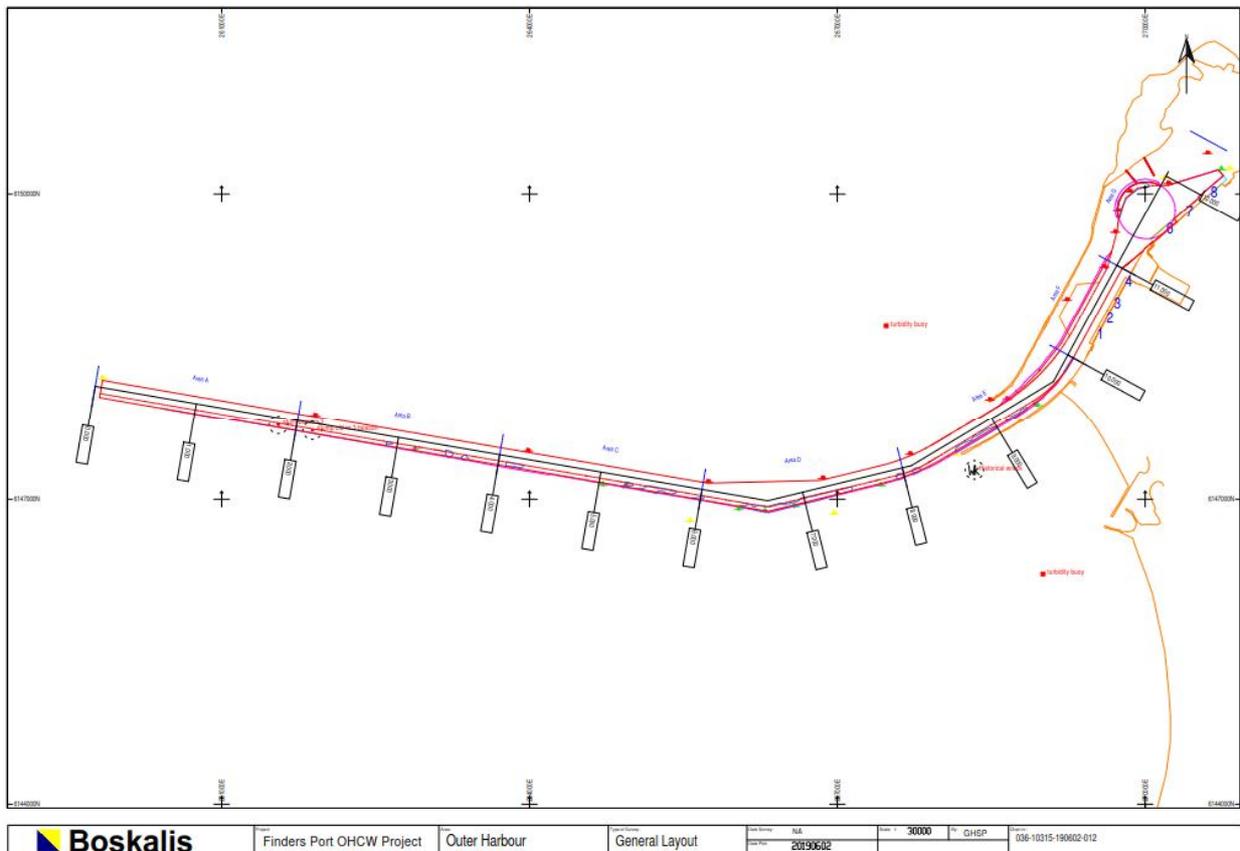
Figure 3.1: Overview dredge area including chainages and area numbering

Dredging in this reporting period took place from the 1st of September until the 18th of September. Dredging was undertaken in all areas of the dredge channel (Figure 3.1) by the Trailing Suction Hopper Dredge (TSHD) *Gateway* and the Backhoe Dredger (BHD) *Magnor*. The TSHD *Gateway* finalised dredging works on 18th of September 07:00 AM and the Backhoe Dredger finalised on Sunday evening 15th of September. In total the *Gateway* completed 46 trips in this period, the *Union Topaz* completed 30 trips and the *Union Onyx* 28 trips to the Dredge Material Placement Area (DMPA). The TSHD *Gateway* demobilized on 20th of September at 8:00 AM to Singapore, the barges departed on Monday 23rd of September 8:30 AM and the BHD *Magnor* on 10:30 AM to Melbourne.

Table 4.1 provides an overview of turbidity exceedances occurred during this reporting period and actions taken. For an overview of dredge areas, see Figure 3.1. For the turbidity data reference is made to [10].

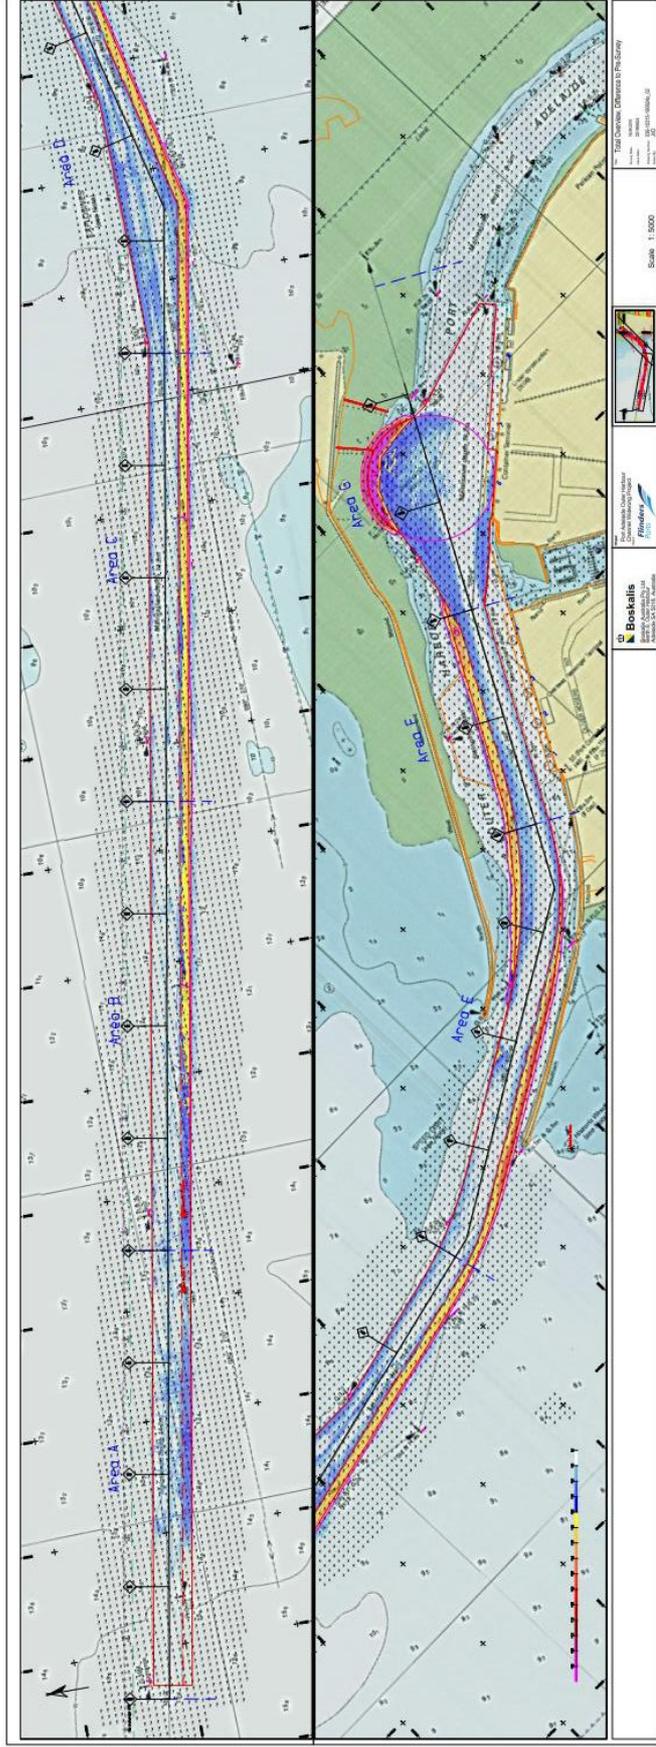
Figure 3.2: Difference in pre-survey compared to survey on the 18th of September

A total volume of 1,487,208 m³ has been dredged and deposited at the Dredge Material Placement Area (DMPA). Volume dredged in September is 100,212 m³. Figure 3.2 gives an overview of the areas dredged based on survey on the 18th of September compared to the pre-dredge survey, where red/pink indicates large dredge volumes and blue small volumes. Figure 3.3 provides an overview of the difference to design, showing all material to design has been removed.

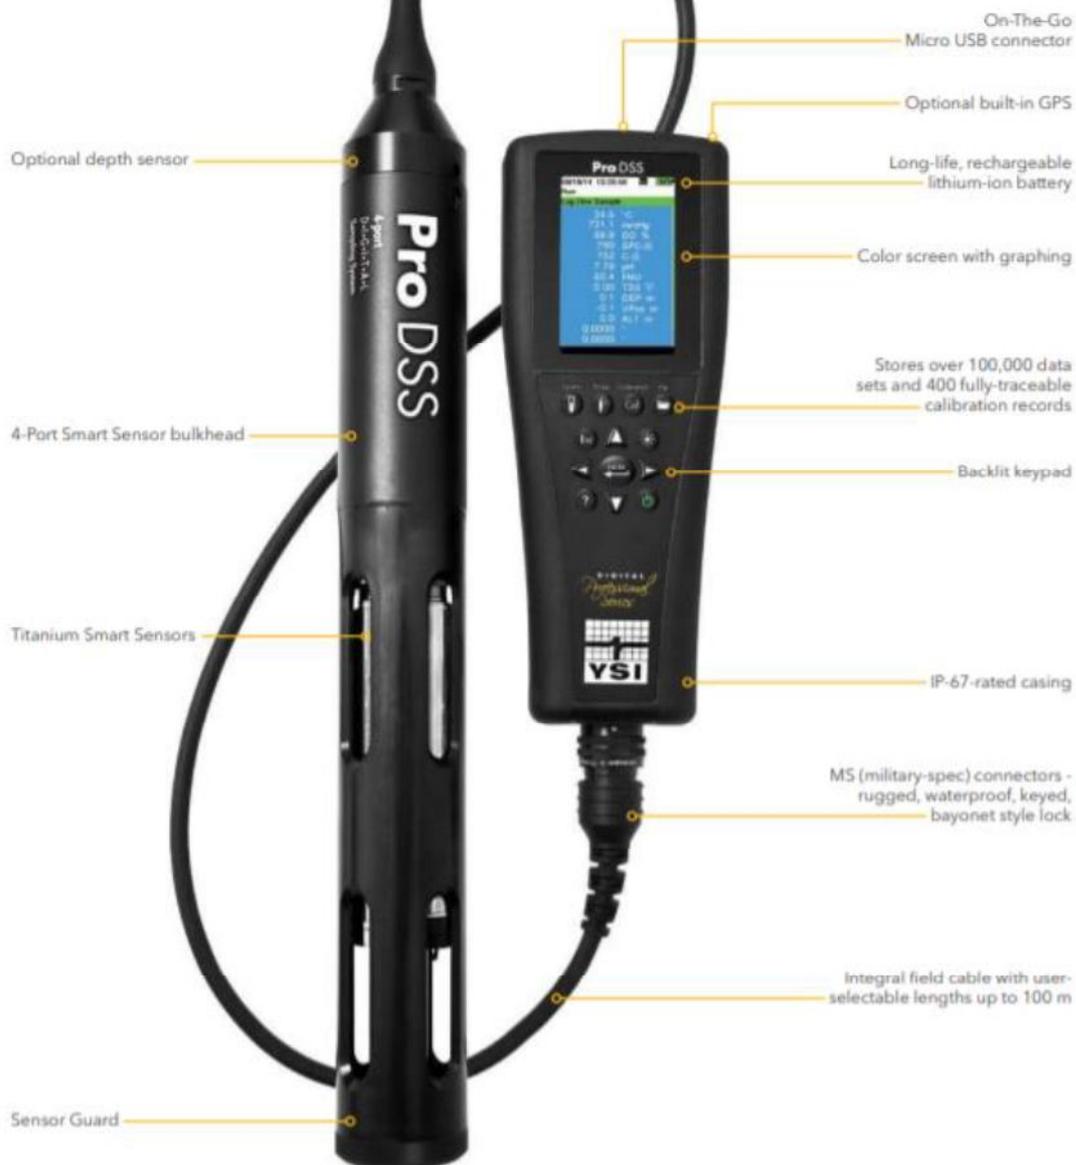
ProDSS Sensor Specifications

Sensor/Parameter	Range	Resolution	Accuracy
Temperature	-5 to 70 °C (temperature compensation range for DO mg/L measurement: -5 to 50 °C)	0.1 °C or 0.1 °F (user selectable)	±0.2 °C
pH	0 to 14 pH units	0.01 pH units	±0.2 pH units
ORP	-1999 to 1999 mV	0.1 mV	±20 mV
Dissolved Oxygen	0 to 500%, 0 to 50 mg/L	0.01 mg/L and 0.1%, or 0.1 mg/L and 1% (user selectable)	0 to 200%: ±1% of reading or 1% saturation, whichever is greater 200 to 500%: ±8% of reading 0 to 20 mg/L: ±0.1 mg/L or 1% of reading, whichever is greater 20 to 50 mg/L: ±8% of reading
Barometer	375 to 825 mmHg	0.1 mmHg	±1.5 mmHg from 0 to 50 °C
Conductivity	0 to 200 mS/cm	0.001, 0.01 or 0.1 µS/cm (range dependent)	0 - 100 mS/cm: ±0.5% of reading or .001 mS/cm, whichever is greater 100 - 200 mS/cm: ±1.0% of reading
Specific Conductance*	0 to 200 mS/cm	0.001, 0.01, 0.1 mS/cm	0 - 100 mS/cm: ±0.5% of reading or .001 mS/cm, whichever is greater 100 - 200 mS/cm: ±1.0% of reading. User selectable reference temperature (15 to 25 °C; default 25 °C) and compensation coefficient (0 to 4%/°C; default 1.91%)

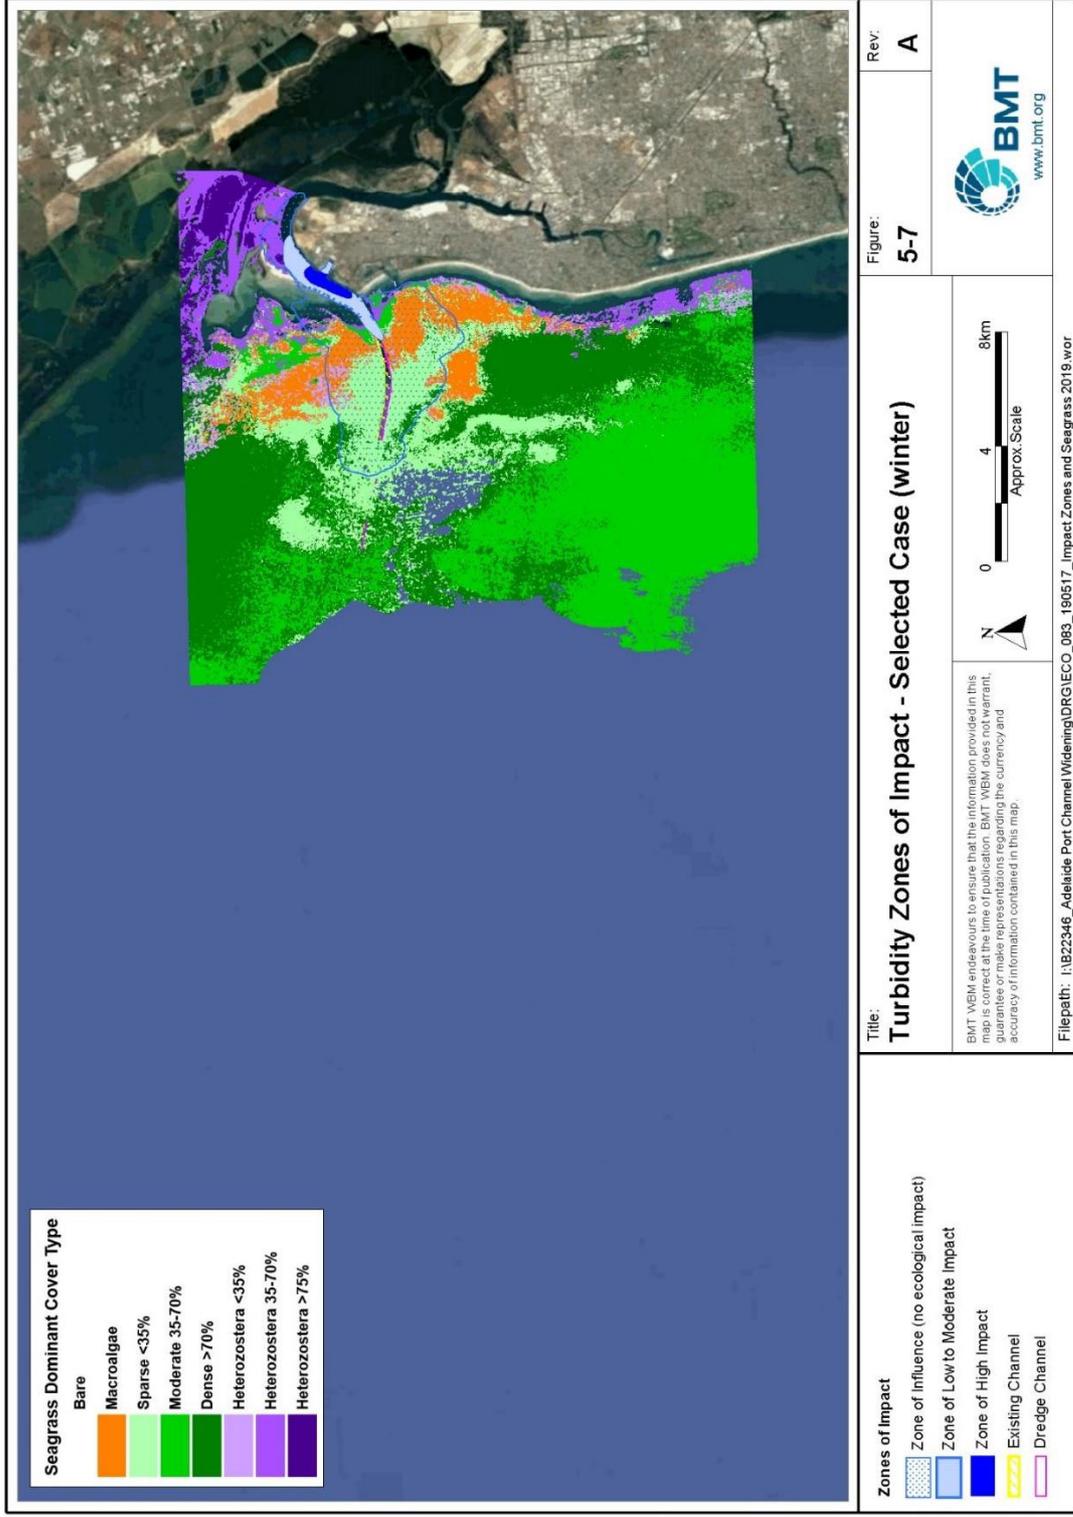
Figure 3-1 Turbidity Zones of Impact

The turbidity impact map for the selected case winter scenario is shown in **Error! Reference source not found.**; the impact map includes the seagrass extent as surveyed in May 2019.

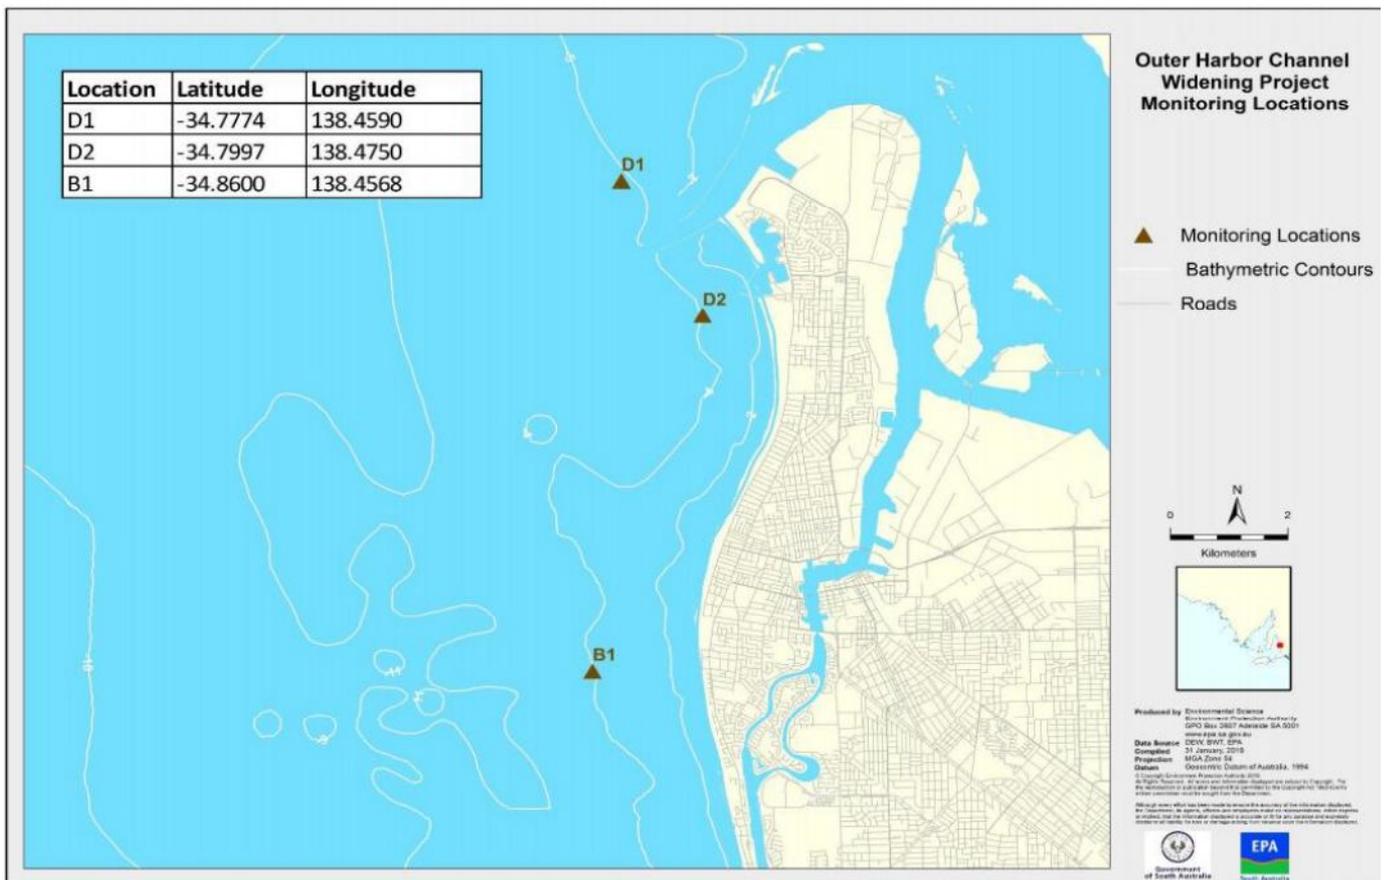
Figure 3-2 Water quality monitoring locations

- Two ‘dredge plume monitoring’ sites – one site located to the north of the channel (D1) and one site to the south of the channel (D2). These sites are located near to seagrass meadows and within the predicted zone of influence as indicated by dredge plume modelling.
- One ‘background’ site - located approximately 5.5 km from the channel dredging area and representing background conditions.

The monitoring sites are shown in Figure 3-2. All three sites are located in a water depth of approximately -8 m LAT.

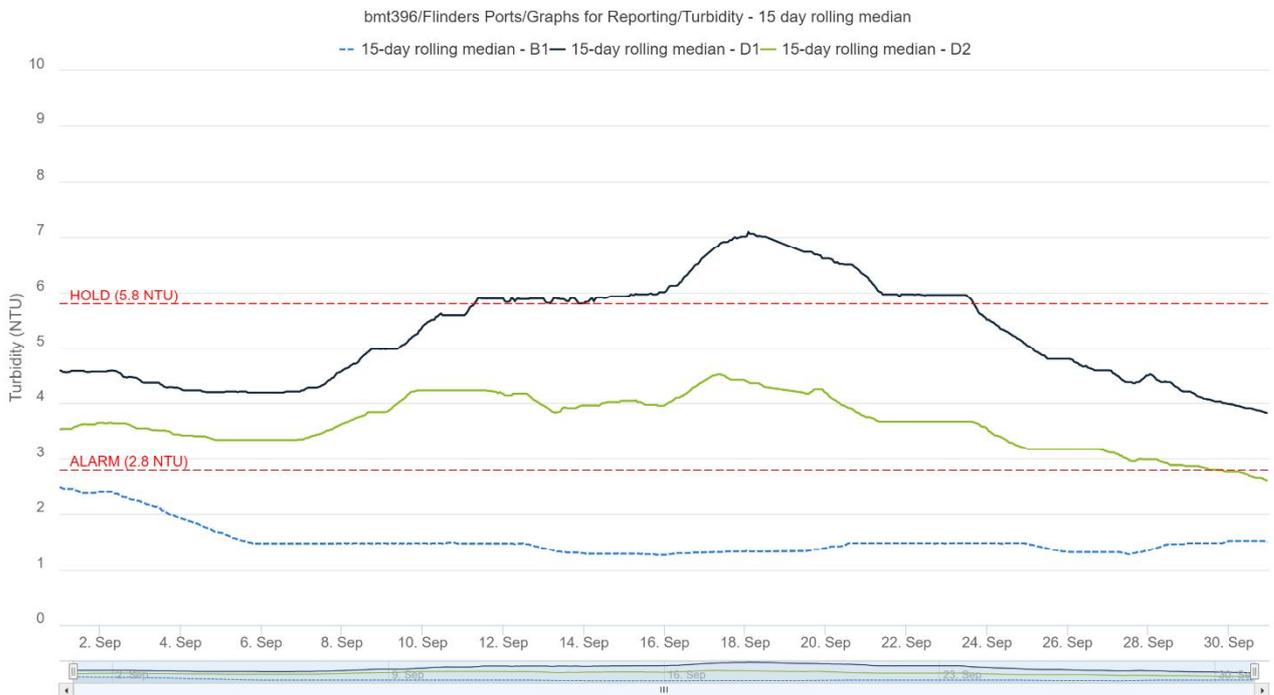
Figure 4-2 15 day rolling median QA' ed turbidity data (NTU) for B1, D1 and D2 – September 2019

The 15-day rolling median turbidity (chronic condition) for September is shown in Figure 4-2, with the range of medians provided in Table 4-1. Figure 4-3 shows the 6-day rolling median turbidity (acute condition) for the month of September.

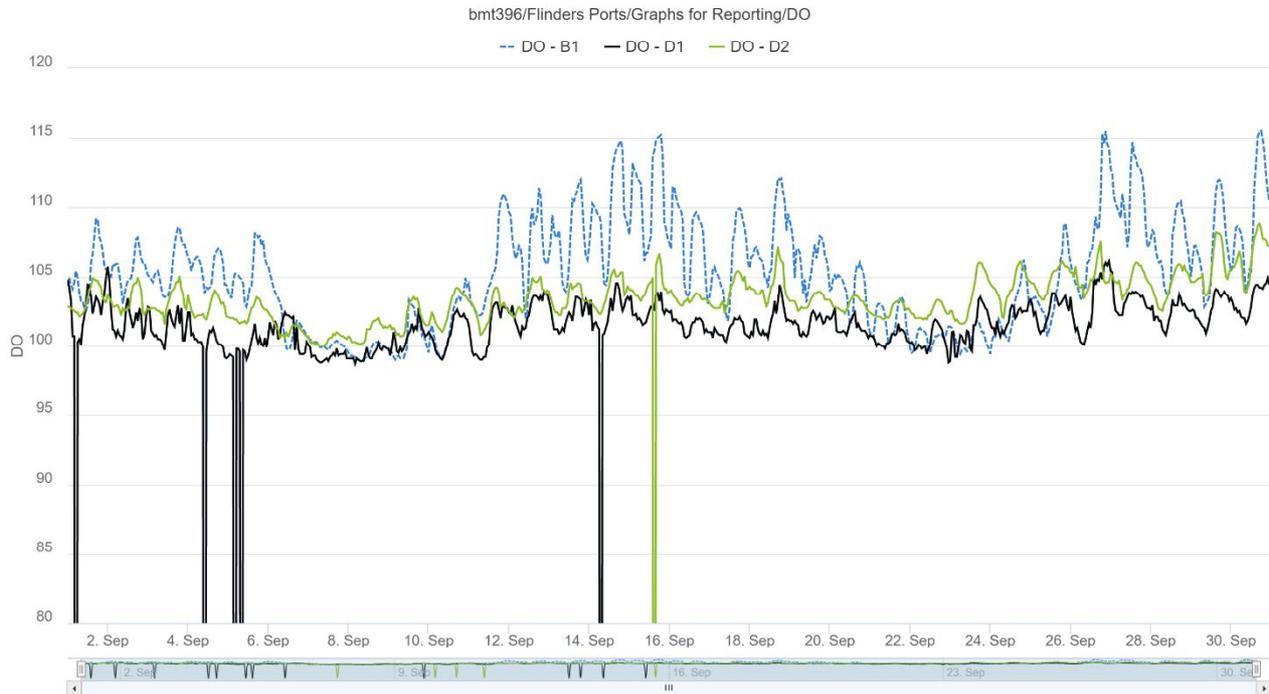
Figure 4-4 Dissolved Oxygen (% saturation) at B1, D1 and D2 – September 2019

Dissolved Oxygen was steady throughout the month of September, ranging between 95 and 110% saturation for site D1 and D2 as shown in Figure 4-4, which is within the default trigger value range for marine waters (ANZECC, 2000). Site B1 had marginally higher Dissolved Oxygen concentrations (up to 115%) from the 12th to the 18 September. Note that there were some signal failures in the data set below.

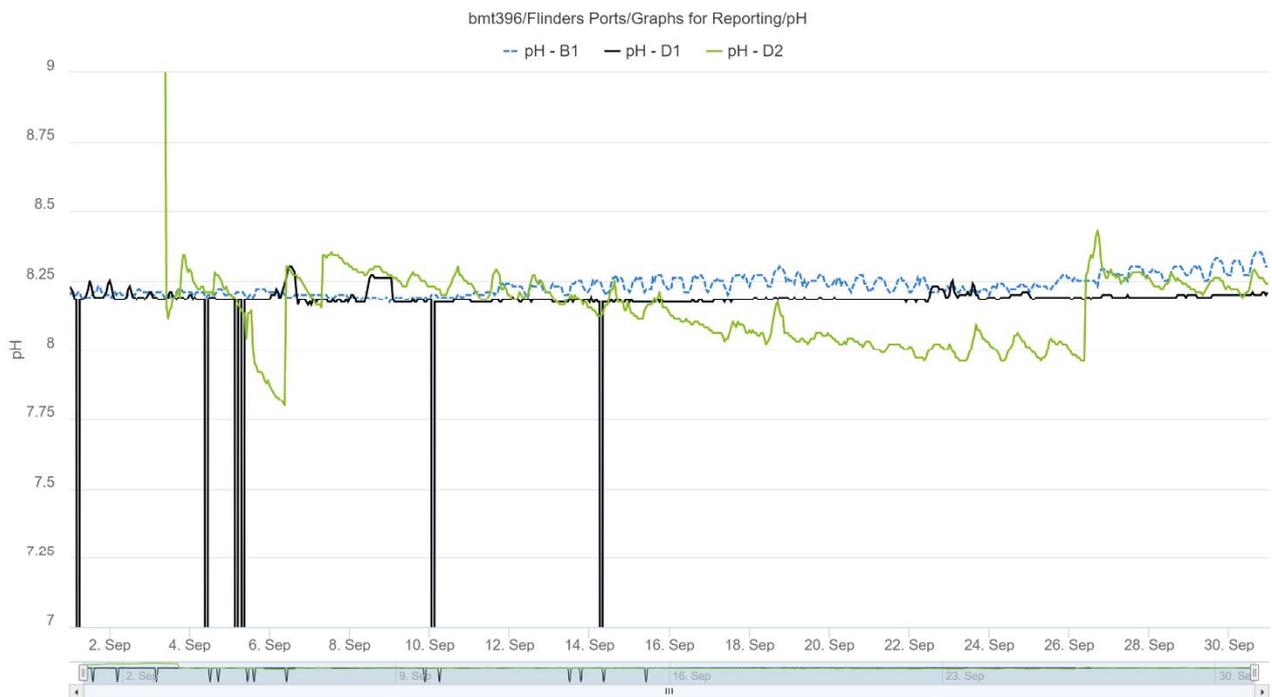
Figure 4-5 pH at B1, D1 and D2 – September 2019

pH ranged between 8.1 and 8.3 for sites B1 and D1 as shown in Figure 4-5 which is well within the default trigger value range for marine waters (ANZECC, 2000). pH at site D2 ranged between 8 and 8.3 up until the 18th of September. Note that there were some signal failures in the data set below.

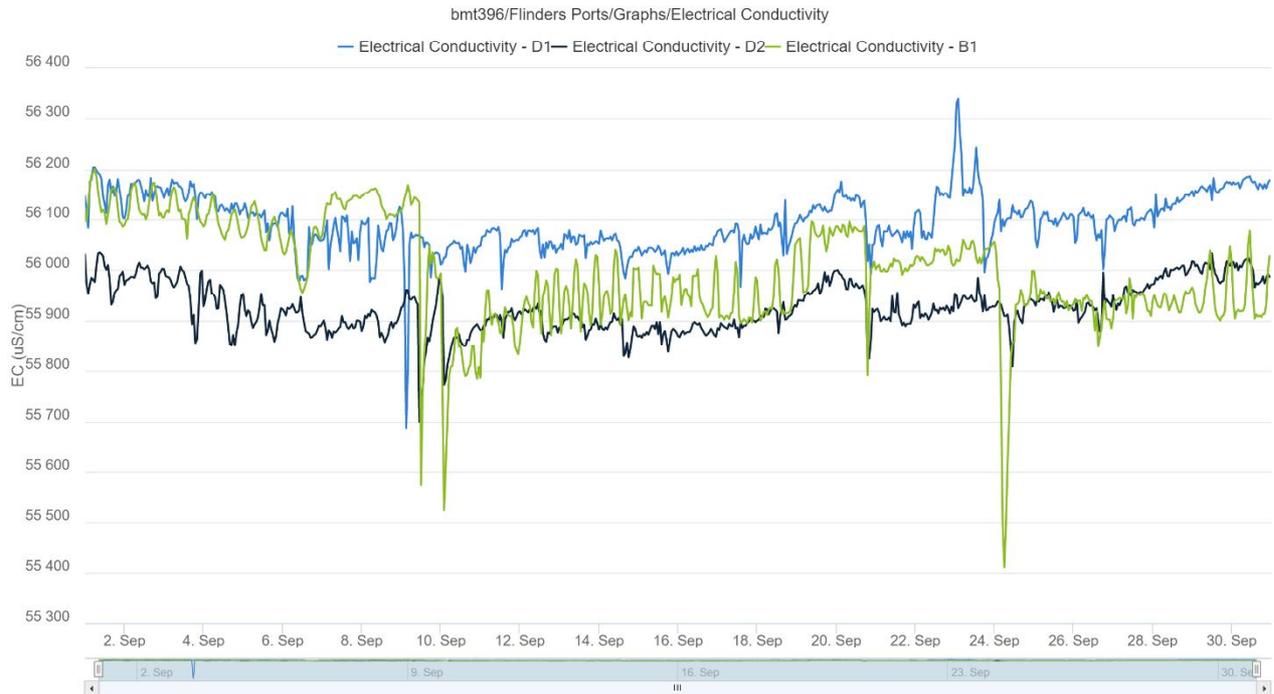
Figure 4-6 Electrical Conductivity (µS/cm) for B1, D1 and D2 – September 2019

Electrical Conductivity (EC) ranged between ~55,400 and ~56,400 μ S/cm, as shown in Figure 4-6.

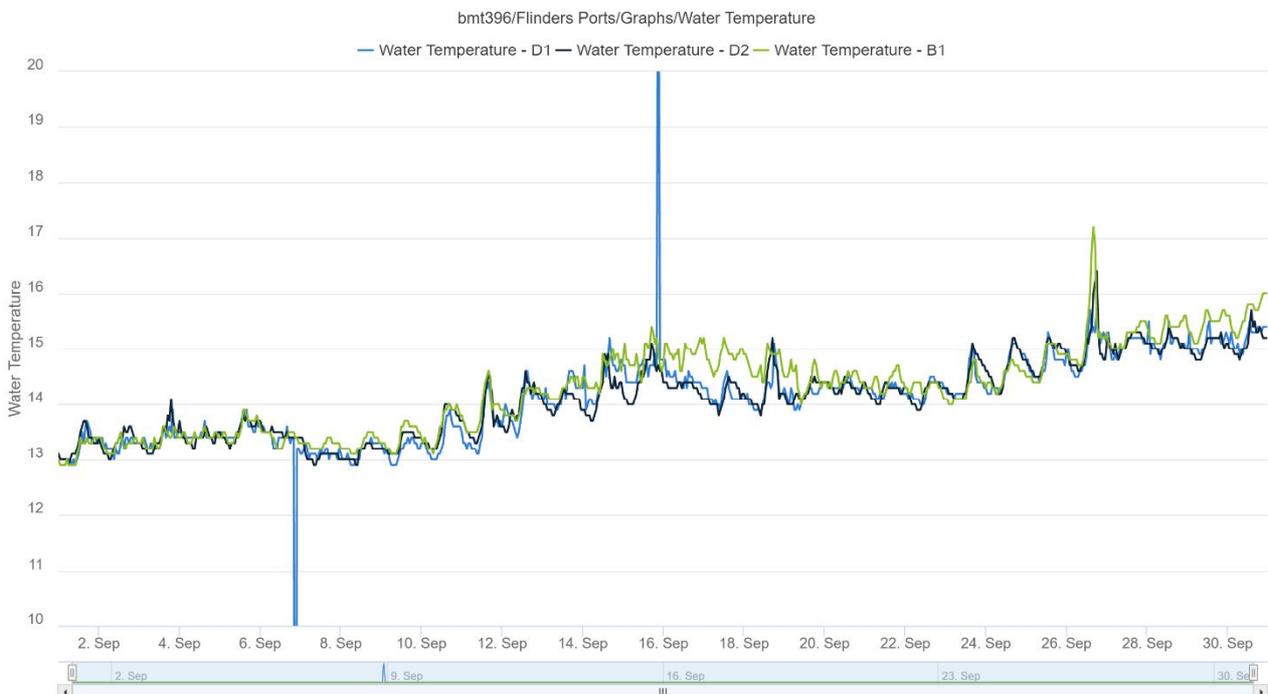
Figure 4-7 Temperature (°C) for B1, D1 and D2 – September 2019

Water temperature remained between 13 and 16 degrees as shown in Figure 4-7.

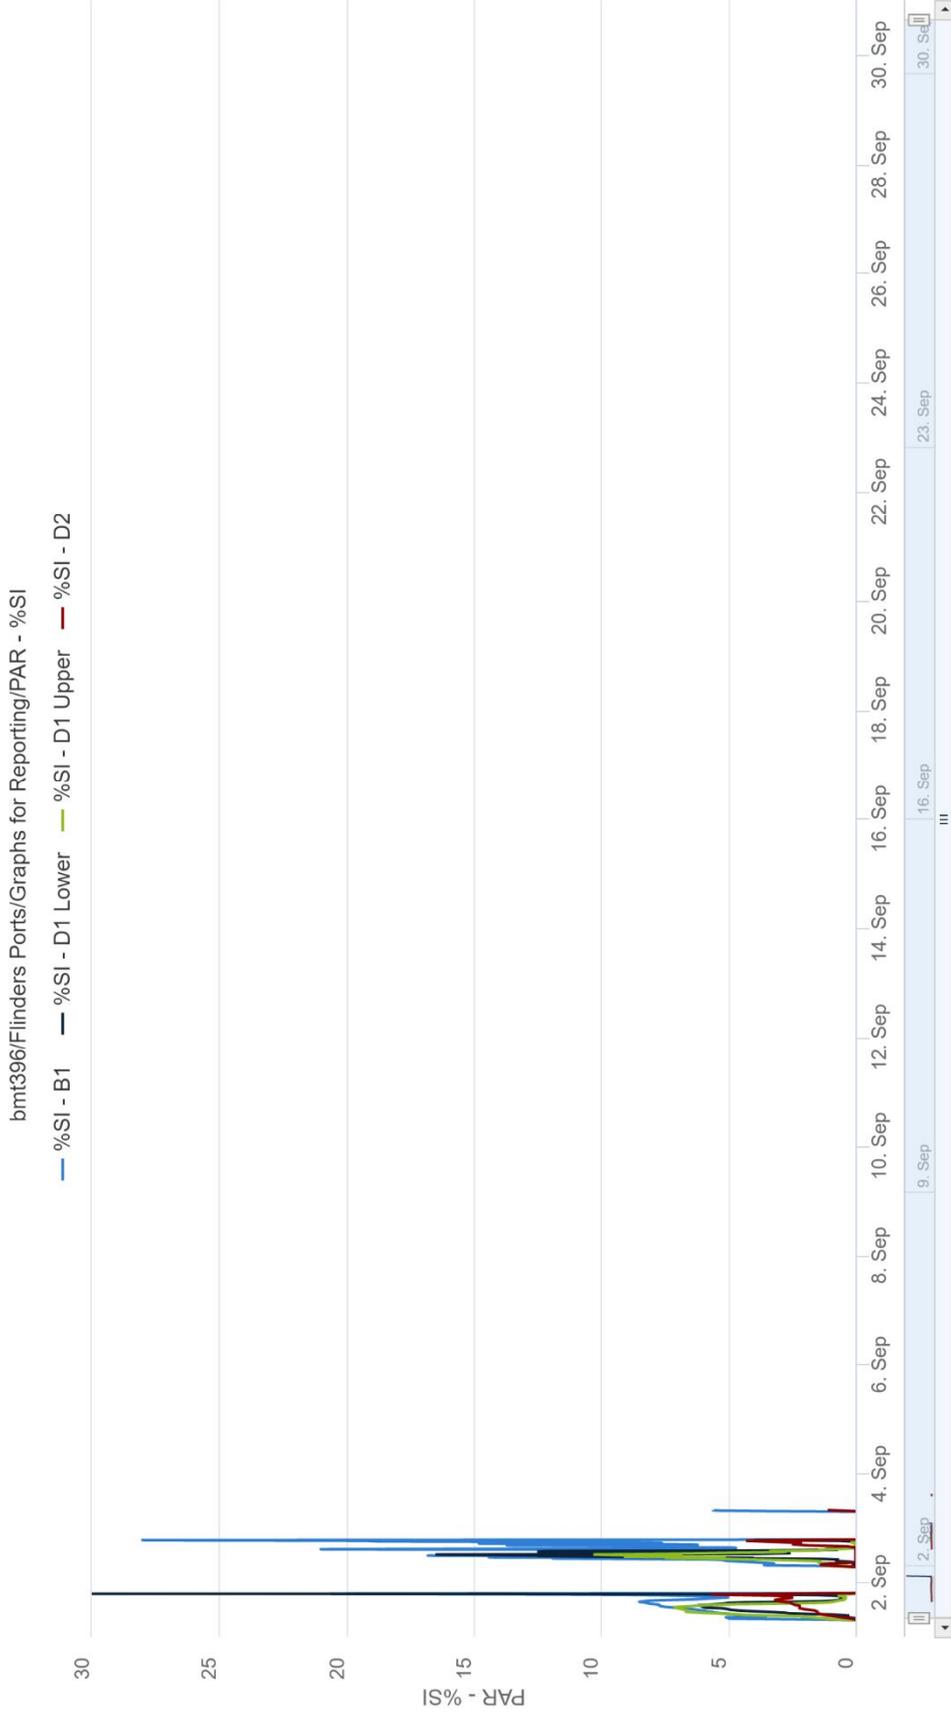
Figure 4-8 % surface light irradiance at B1, D1 and D2 – September 2019

Data is displayed from the 1st to the 3rd of September. The remainder of the PAR data will be published upon retrieval of the PAR instrumentation.

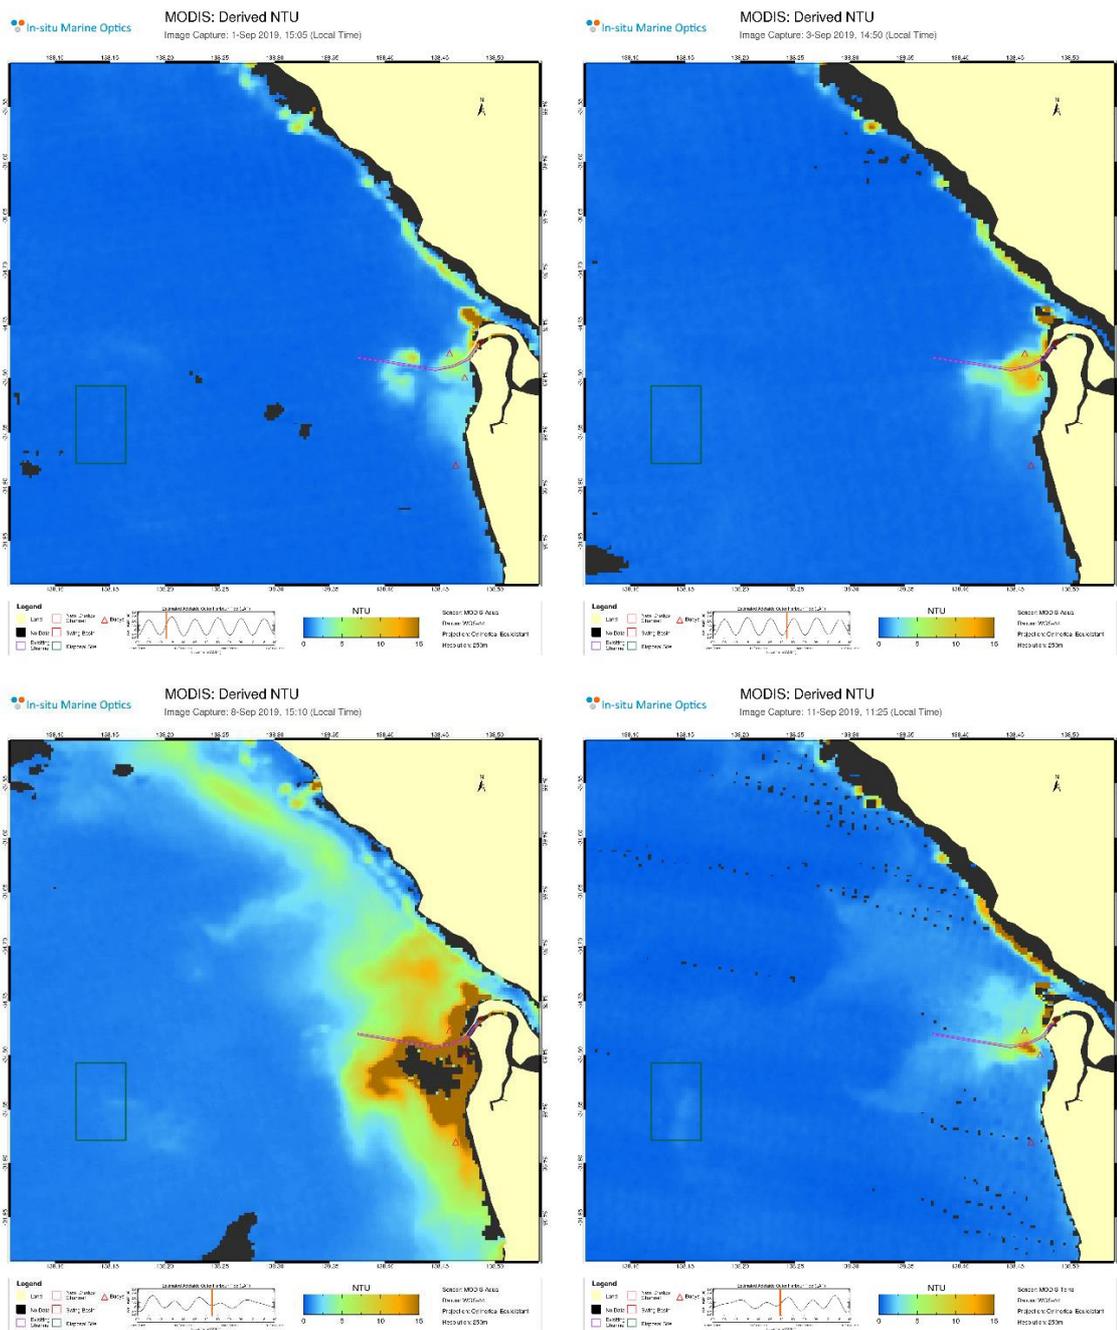
Figure 5-1 Satellite images during September (1st, 3rd, 8th, 11th)

A dredge plume model validation review was undertaken using the satellite imagery collected as part of the dredge plume monitoring program. The review has considered satellite images collected during September utilising those images that contained the clearest imagery. The satellite imagery does show significant plumes along the length of the coastline within the satellite image during the high wind events (6th -10th and 12th-23^d), however turbidity reduced rapidly within 1-2 days (Figure 5-1; Figure 5-2).
